Technical Bulletin

TB-96829 / August 9, 2017

B150M Thru-Hull Transducer Transformer Issue

Product:	000-13922-001; 000-13921-001; 000-13920-001
Product Description:	B150M Transducer
Effective Date:	August 9, 2017
Inspect/Update Current Inventory:	N/A

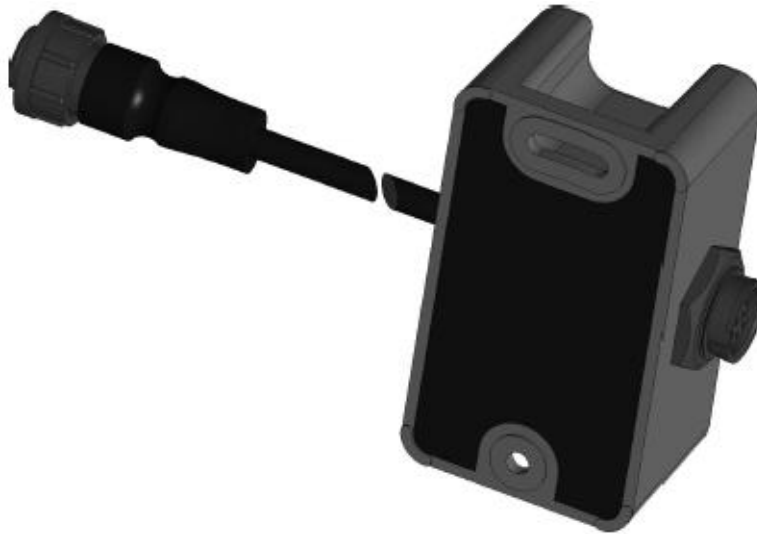
Airmar Matching Box P/N 985-11552-001

We have discovered that a number of xSonic B150M transducers have been manufactured with an incorrect transformer. This could result in performance degradation over time, and in extreme cases, transducer failure.

To resolve the issue, Airmar® has supplied a matching box (shown below) that can be used inline between the transducer and echosounder.

Customers or dealers with transducers within the effected S/N range can order the matching box P/N 985-11552-001 at no charge by contacting your Navico® Service Center.

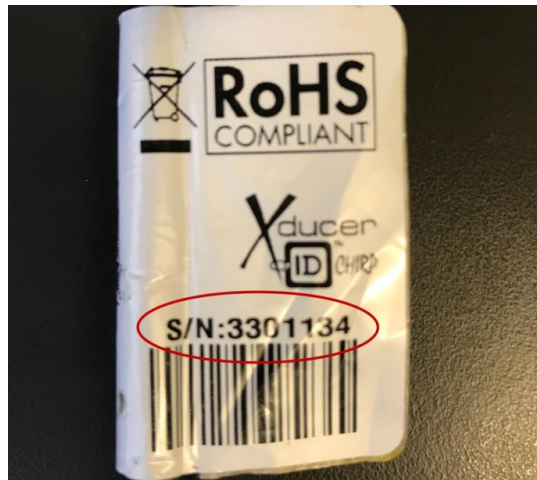
The serial number can be found on the Airmar tag on the plug end of the transducer cable as shown above.

This issue affects B150M xSonic transducers with 0, 12 & 20 degree tilt in the following serial number range:
